THE APPEARANCE OF A BORIC OXIDE EXHAUST CLOUD

FROM A TURBOJET ENGINE OPERATING

ON TRIMETHYLBORATE FUEL

By Albert M. Lord and Warner B. Kaufman

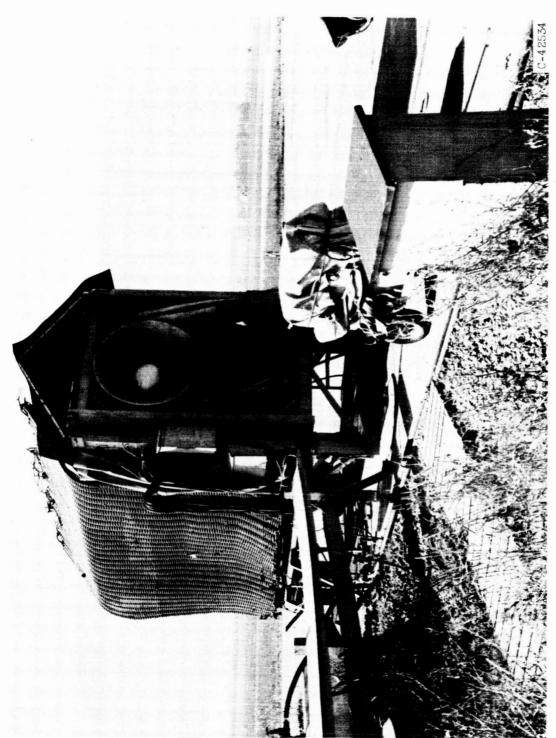
Figure 1. - Installation of J47-25 turbojet engine for smoke tests.

a) Engine inlet.

The J47-25 turbojet engine used for this investigation was mounted in a test stand at the edge of the NACA hangar apron at Cleveland Hopkins Airport. The installation is shown in figure 1. A mat woven of steel cables was suspended over the engine to provide protection for observers and operating personnel in the event of an engine failure.

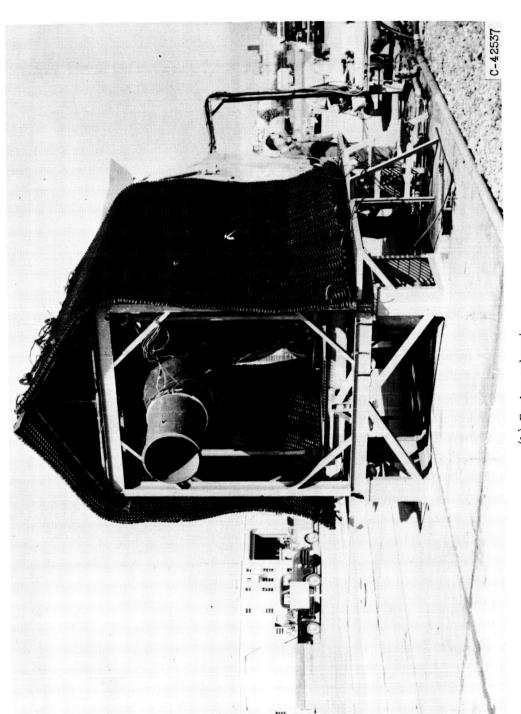
Figure 1. - Concluded. Installation of J47-25 turbojet engine for smoke tests.

(b) Engine exhaust.

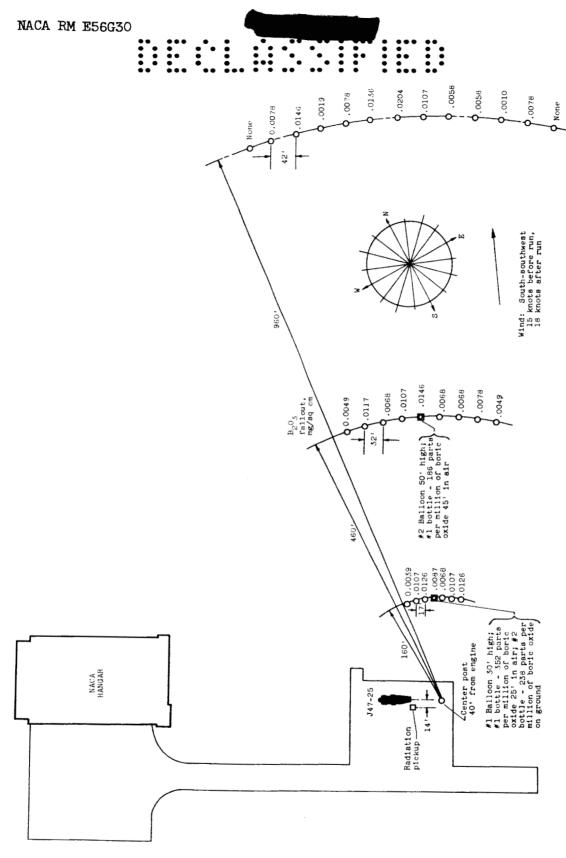
Figure 2. - Arrangement of fallout and air-borne dugt sampling devices and the concentrations collected.

The engine exhaust stream was emitted in an easterly direction. The wind was from the south-southwest at the time of the test. On the basis of the expected path the wind-borne exhaust cloud would follow, beakers partly filled with water were located on the ground as shown in figure 2 in an effort to determine the fallout concentration. In addition, vertical sampling of the exhaust cloud was attempted by suspending evacuated bottles at various levels from cords supported by weather ballons.

The results of the analysis of the boric acid in the sampling beakers and the concentration of boric oxide in the evacuated bottles is indicated in figure 2. The concentration of boric oxide in the beakers appears to be a maximum near the center of the layout, which indicates good coverage of the exhaust gases. Although the cloud itself was dense, there was no evidence of its path on the ground after the test.

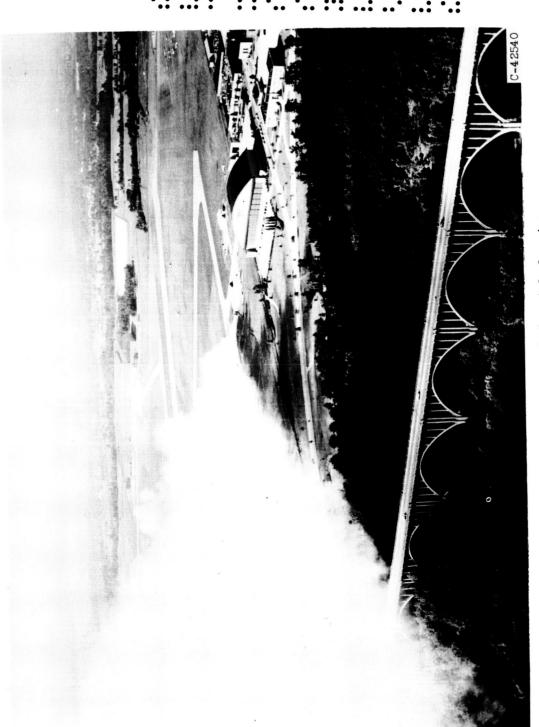
(a) View from helicopter 2500 yards downwind of engine.

Figure 5. - Boric oxide smoke cloud from exhaust of turbojet engine burning trimethyl-borate fuel.

Boric oxide in the exhaust gases was visible as soon as trimethylborate entered the engine. The density of the exhaust cloud increased proportionately with the increasing trimethylborate - JP-4 ratio. After 4 minutes of operation on trimethylborate, the boric oxide cloud had risen to a height of about 2000 feet. Figure 3(a) is a photograph of the cloud taken from the helicopter. The angle of this photograph is such that the cloud appears denser than it would in a right-angle view. The centerline of the cloud rose as it was blown away from the engine; however, dispersion of the cloud kept the lower edge near the ground. At distances up to 800 feet downwind of the engine, objects could not be seen through the cloud when it was forced to the ground. At 1000 feet and beyond, objects could be perceived through the cloud. The cloud moved off with the wind and spread slowly after shutdown. It was still visible about 10 minutes later.

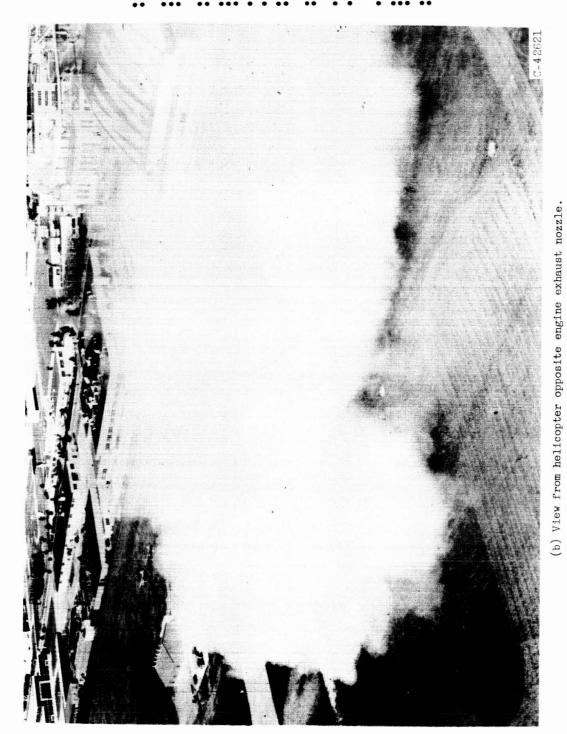
Figure 5. - Concluded. Boric oxide smoke cloud from exhaust of turbojet engine burning trimethyl-borate fuel.

Figure 3(b) shows the cloud from an angle looking toward the exhaust of the engine. The cloud has been caught by the wind and is being deflected to the right.
